RESEARCHES REGARDING SOIL EROSION AND MEASURES TO FIGHT IT ON THE DECLIVITOUS TERRAINS LOCATED IN THE CORNEA AREA (CARAŞ-SEVERIN COUNTY): THEIR IMPACT ON THE LOCALITY

I. NEMEŞ

Politehnica University of Timisoara, Romania

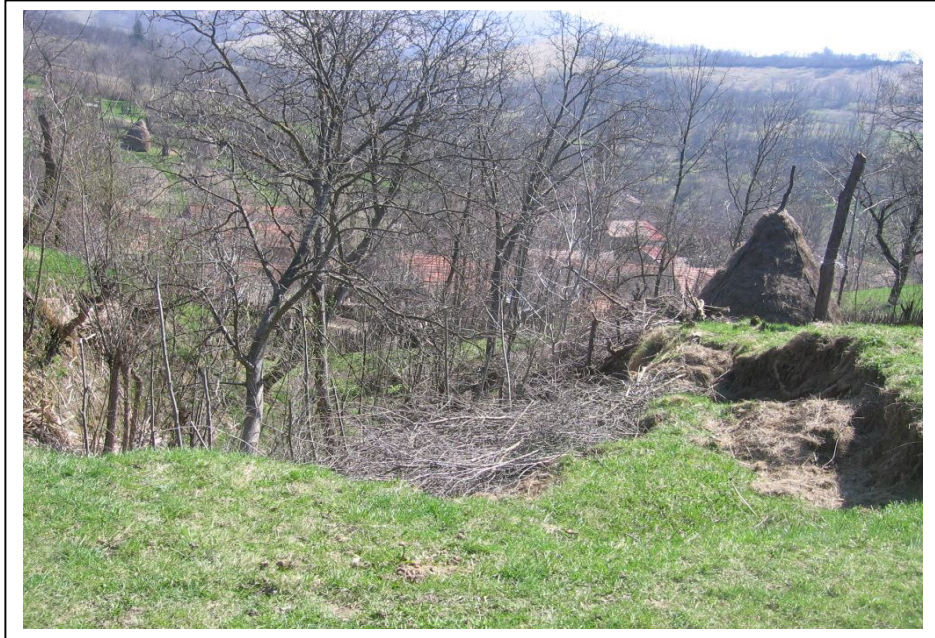
Figure 2. The Cernilova land slip

- For the landslip (small depth and surface landslip), near “Cernilova” base flank we propose the next solution (figure 2):
 - To level away the slip surface
 - Execute a horizontal drain to the base of the slip, that will collected the water from the sandy horizon that are situated under the gliding claying horizon, and will ejected to the emissary situated at the flank base.
 - To level away the area above the slip (an area with micro-dislevelment and furrows from farm equipment circulation)

- A declivous earth wall execution, which will collect the surface water and will eject in the natural outlet from around.

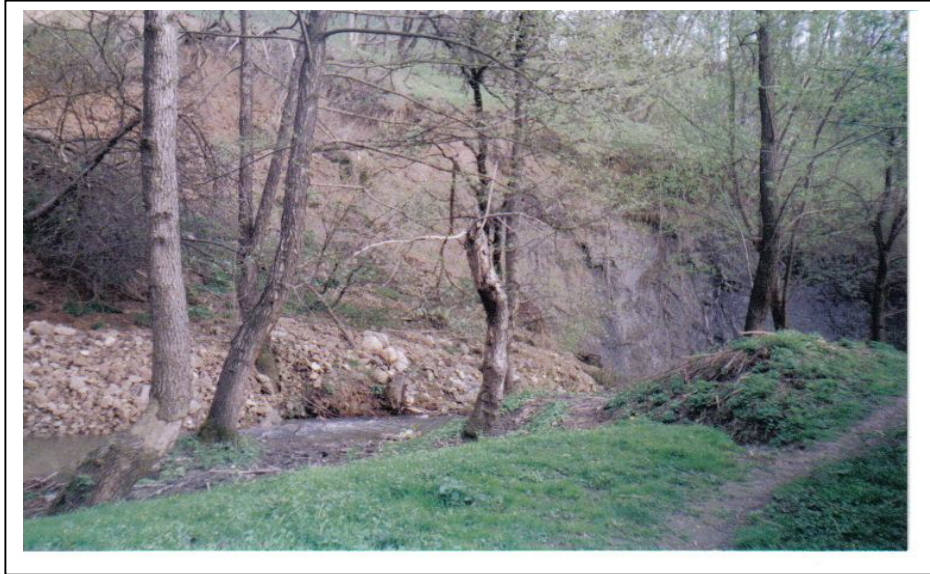
Figure 3. The Cucuiului Hill land slip

- For the landslide situated in Cucuiului Hill we propose the next solution (figure 3):
 - Glen tip formation improvement, situated near the landslide, with an outlet collection channel form, that will undertake the surface water and will eject in “Chișăvăț” River.

- A declivous earth wall execution, upon the landslide, that which conduct the surface water to this outlet.
 - Left bank consolidation of “Chișăvăț” River in the landslide area, by forest works, executing a tail board with 2 m height, for slope of thalweg modifying.

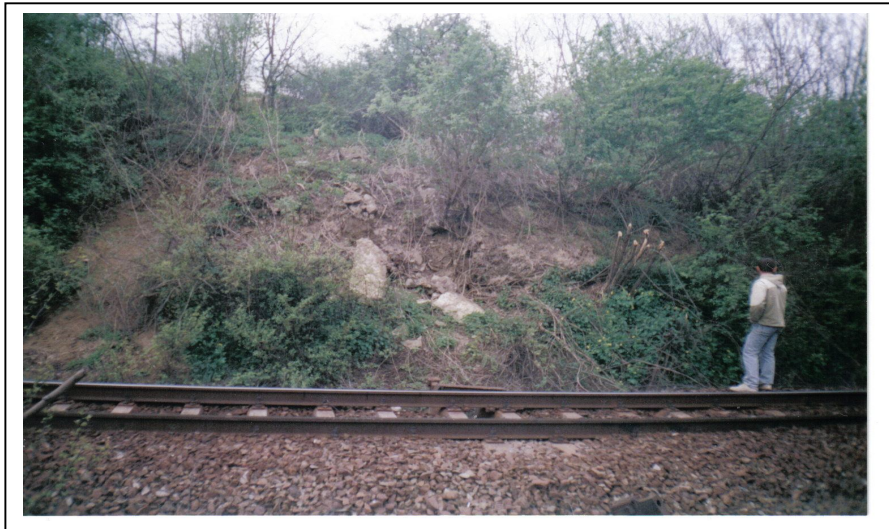
Figure 4. The land slip near the rail road

- For the landslide from figure 4, a landslide that affect the railroad that are situated at the base of the landslide we propose:
 - To execute an abutment from prefabricated pieces.
